# HIGH TEMPERATURE ELECTRONICS TECHNOLOGY

## PHASE II — FINAL REPORT

MAY 1984

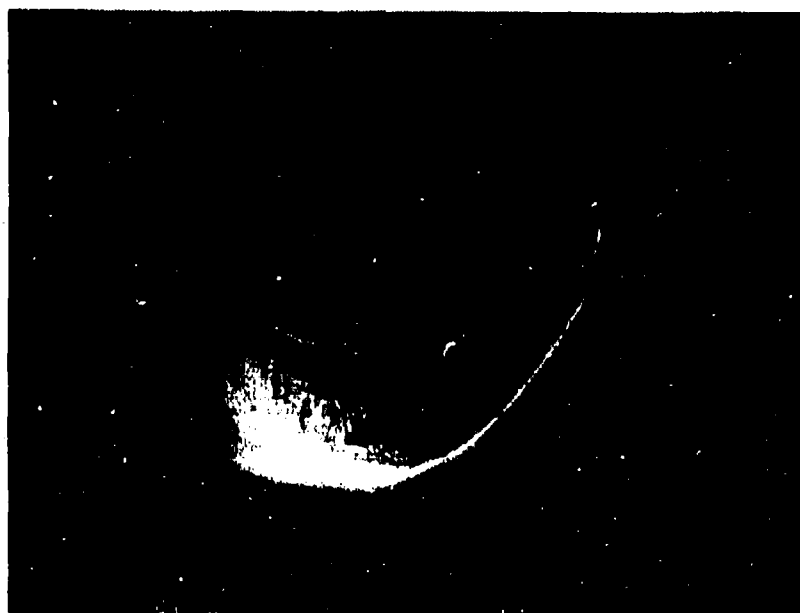
Figure 3-19. Center of Point Defect at 2000X  
Magnification Annealed 100 Hours  
at 365° C.

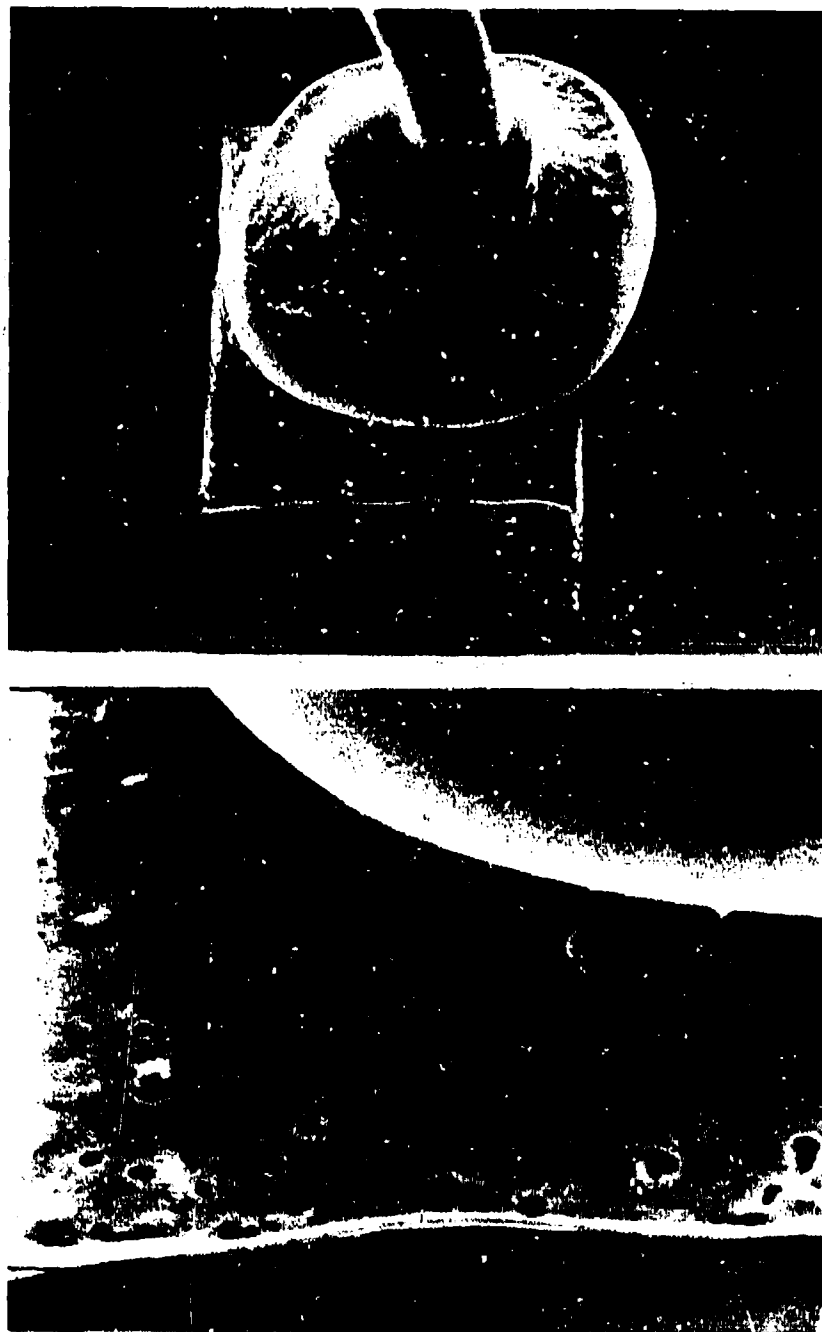
Figure 3-23. Bonding Pad of a Chip Exposed to 340° C for 1600 Hours Illustrates a Single Crystal Hillock Formation.

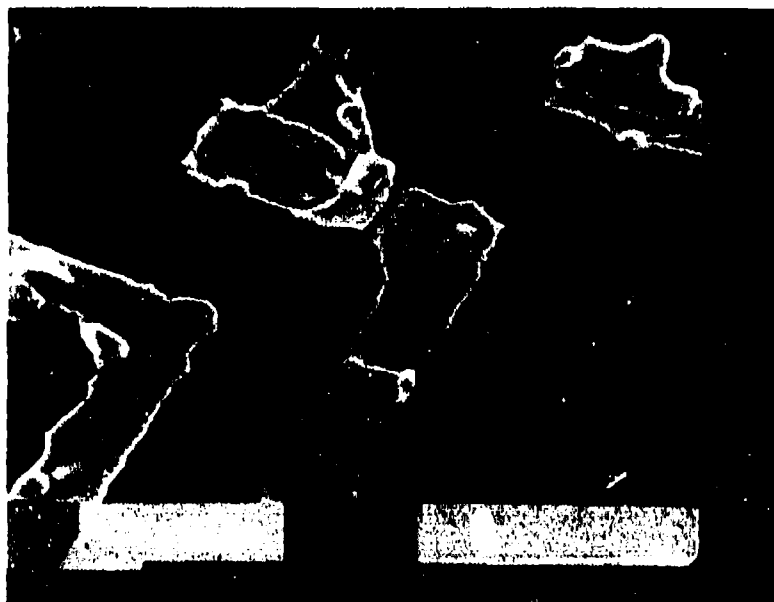
Figure 3-37. Bonding Pad and Ring Oscillator Metallization  
from Chips Which Failed After 320 Hours at 320° C.

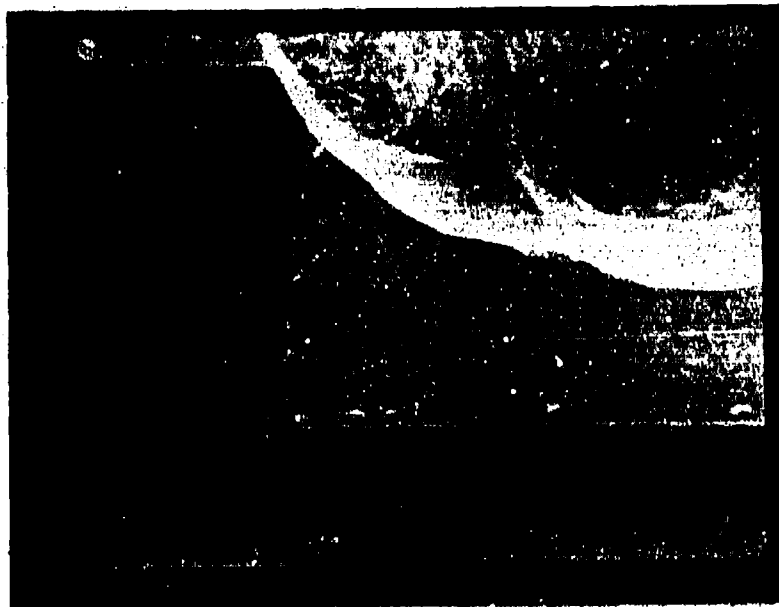
Figure 3-39. Barrier Metallization Anomalies Observed After 420 Hours at 340° C.

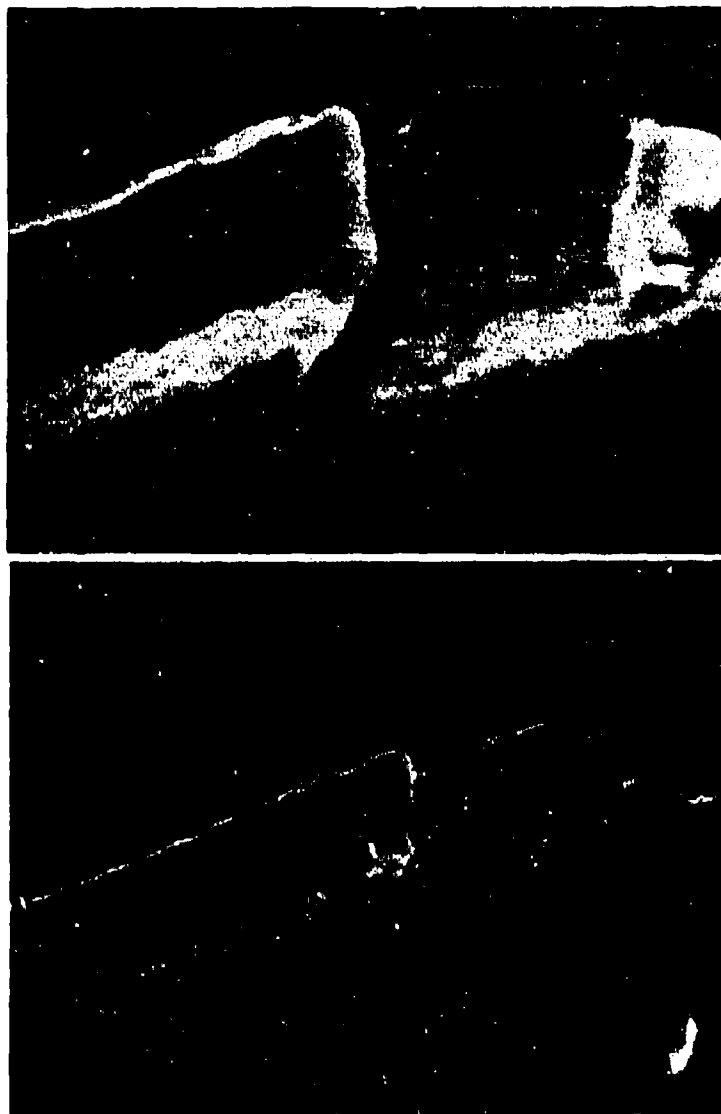
- Cause of Failure is Broken Metallization Runs Caused by Metal Lifting.
- The Nitride Passivation Was Removed From This Sample Before the Photographs Were Taken.

Figure 3-48. SEM Closeup Photographs of Failed Metallization Runs Which Resulted During Life Testing.

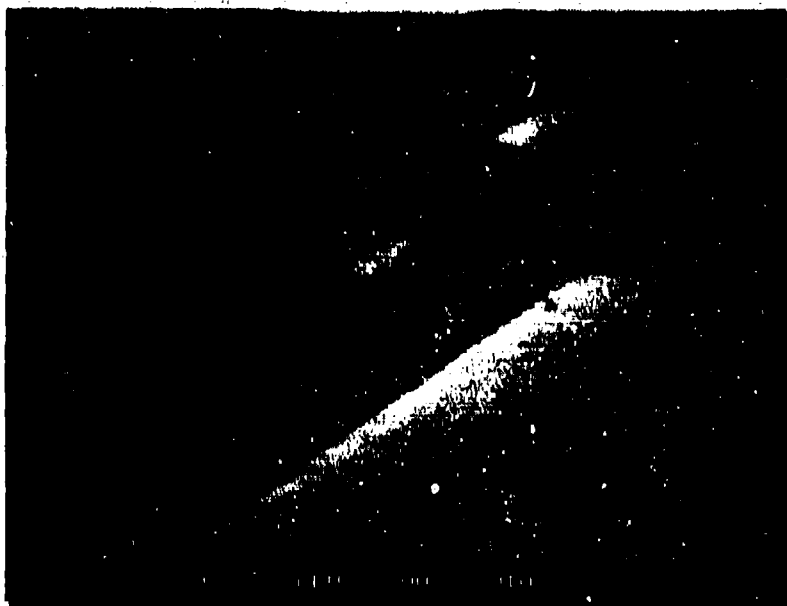
- A Ti-W/Au/Ti-W Metallization Has Been Sputtered on Top of Lift-off Photoresist.
- The Photograph Shows the Point Where the Metal Tears During the Lift-off and Leaves an Upturned Metal Edge.

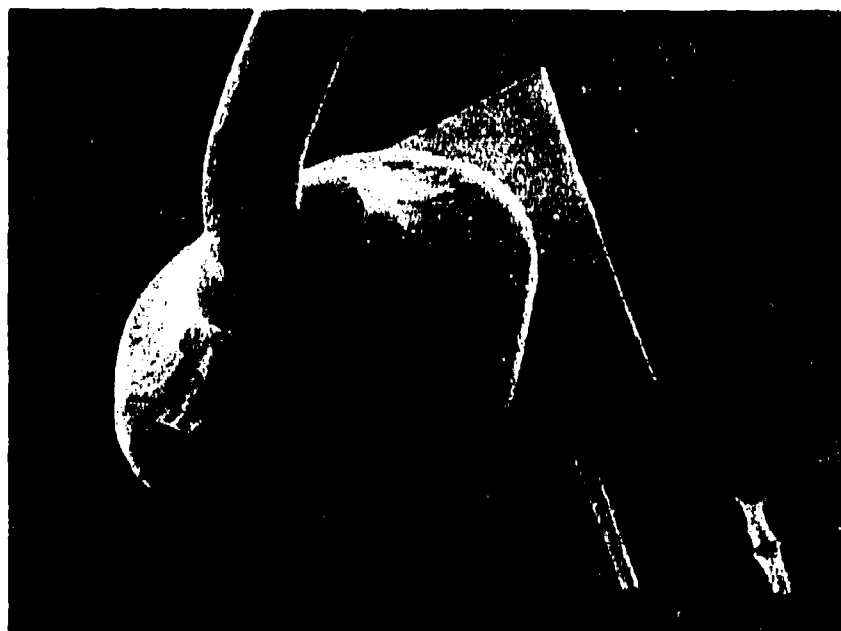
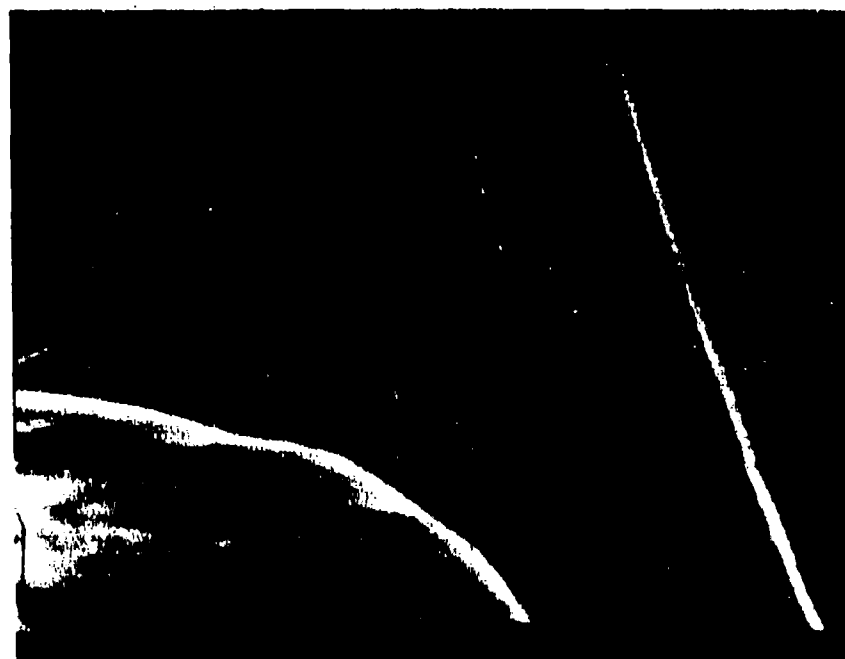
Chip No. 6 was removed from Life Test "B" after 1220 hours at 340° C when all oscillators had ceased to function. A SEM analysis revealed a metallization adhesion problem as the probable cause of failure. Figure 4-4 shows how the metallization started to lift at the edges after 1220 hours at 340° C. Figure 4-5 shows how the narrow interconnect metallization at the interior of the chips lifted except for the via contacts to active silicon. Finally Figure 4-6 shows the metallization lifting around contact openings to the active silicon. The problem with poor metal adhesion was most severe with

Figure 4-4. Metallization Lifting on a Bonding Pad  
After 1220 Hours at 340° C.
